Safety Problem with FIXE Top Chain Anchors

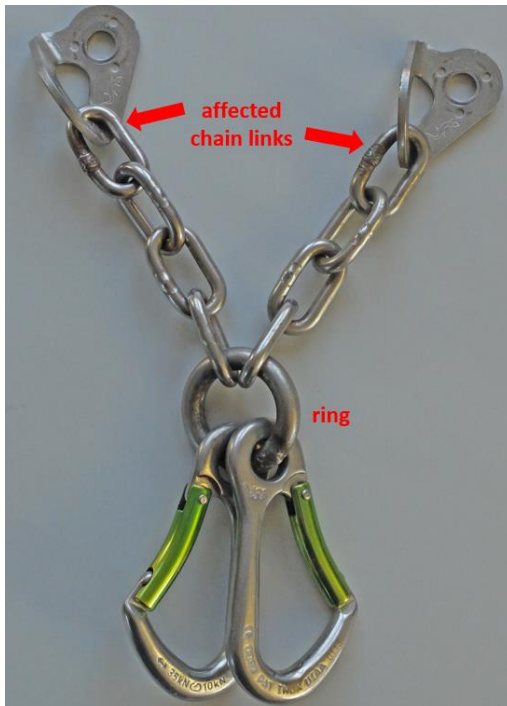
Figure 1: Anchor equalization by FIXE

This summer, a chain link of a FIXE top chain anchor made of stainless steel broke during lowering the climber at an outdoor wall of a climbing hall of the German Alpine Club (DAV). As the design of the top chain anchor equalizes the load between two attachment points (anchor equalization, Figure 1), the failure luckily had no consequences. In the subsequent examination of all top chain anchors at the outdoor wall of said climbing gym further chain links showing fissures were detected. It was always the last chain link which provides the connection to the bolt that was affected. Fissures occurred both in the area of the weld seam and at the leg opposite to the weld seam (Figures 2, 3). The affected top anchor chains had only been used for two years. After safety warnings had been released by the German Alpine Club on July 28 and by FIXE (TechRock) on July 29, top chain anchors that showed fissures in the chain link

Top chain anchors made by FIXE with anchor equalization (Figure 1) made of stainless steel are to be regarded cautiously. In the long run, they ought to be exchanged. At short notice or if you arrive at such an anchor as a climber, the anchors may be secured. In this respect, for example a quickdraw may be connected in parallel to a chain strand (Figure 5).

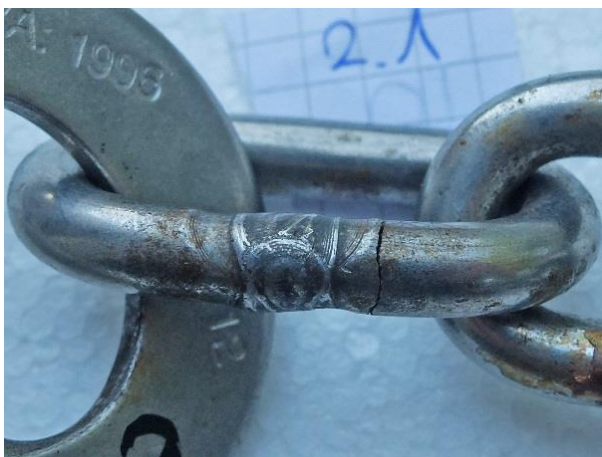
A Spanish laboratory commissioned by the manufacturer FIXE analyzed one of the top chain anchors and certified stress corrosion cracking, SCC, as cause for the fissures observed.

Figure 2: Chain link showing average traces of corrosion and an obvious fissure.

Stress corrosion cracking is the result of a combination of three factors: the material is susceptible to stress corrosion cracking, tensile stresses act upon the link (by internal thermal stresses within the link or external loads) and the environment promotes corrosion. An environment which promotes corrosion is almost always given in the outdoor area. Proneness of the material to stress corrosion cracking is created by the manual welding process of stainless steel, as far as we know. The chain link connected to the bolt which is affected by fissures is manually welded by the manufacturer FIXE and shows anomalies of structure in the metallographic

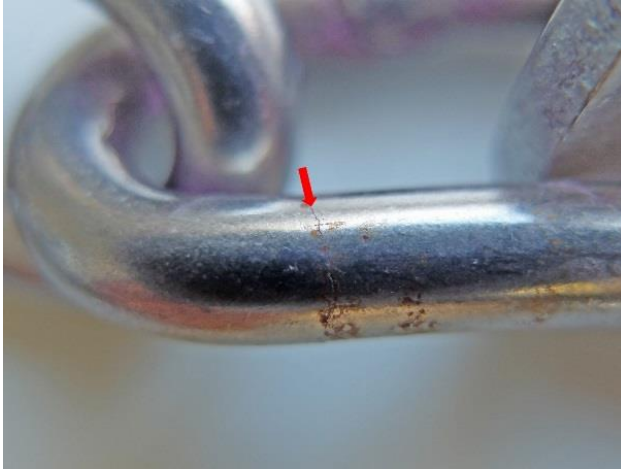
Figure 3: Chain link showing a fine fissure opposite to the weld seam.

of the German Alpine Club one chain stuck out at which only a very thin fissure was visible (Figure 3) but which only had a residual breaking strength of 5,6 kN! Visual control thus has to be executed very thoroughly. Stress corrosion cracking may occur at any point during the lifetime of a member. One single inspection is thus not sufficient to eliminate the problem.

FIXE top chain anchors in serial connection made of stainless steel ought to be investigated with respect to traces of corrosion and fissures by operators of climbing gyms and persons in charge of climbing crags. In this investigation the focus has to be on the last link which provides the connection to the bolt and on the ring at the second bolt. The investigation has to be carried out thoroughly as the fissures may be relatively fine (Figure 3).

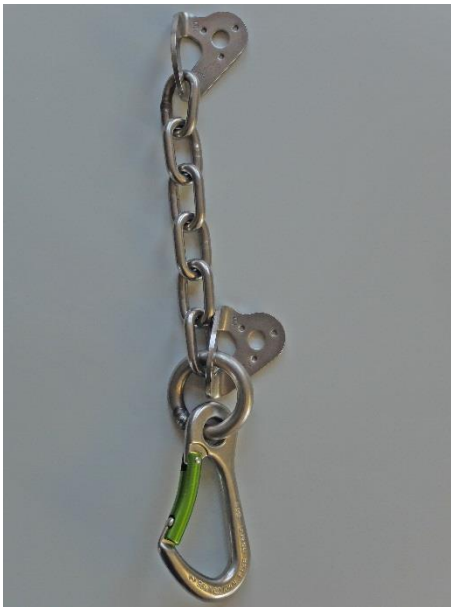
Figure 4: Top chain anchor by FIXE in serial connection.

Two questions remain in connection with the issue. First: may also top chain anchors with a serial connection be affected (Figure 4)? Here, the chain is serially connected as a redundancy system and is not under load. Thermal stresses, generated by the welding process, would have to cause the corrosion without additional introduction of load. And second: may also the ring which connects both chains (in case of anchor equalization) or which connects the chain and the bolt (in case of serial connection) be affected by stress corrosion cracking? This ring is also welded manually but has a substantially larger cross section. Thus, there is basically a greater safety buffer and the tensile stresses within the material are lower. Up to now, no ring with fissures has been detected. In the analysis of the top chain anchors comprising fissured chain links the rings neither comprised fissures nor showed reduced strengths.

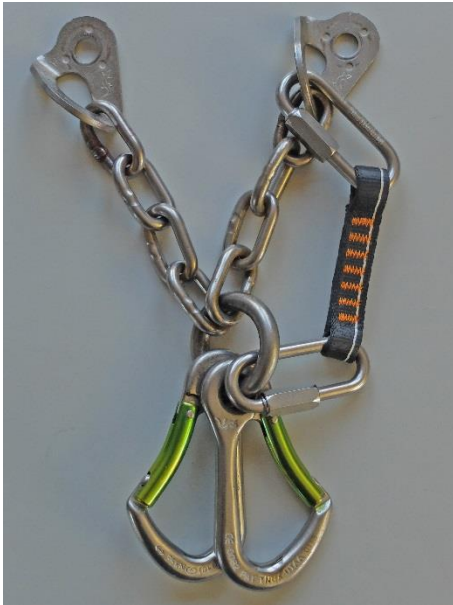
Figure 5: Redundancy using a quickdraw
