Climbing Gym Meeting2025

Critical incidents, accidents, risks, and recommendations from the DAV for auto belay devices

Halls & Walls 22.11.2025, Lorenz Berker, Dr. Tanja Ganz – sifo@alpenverein.de

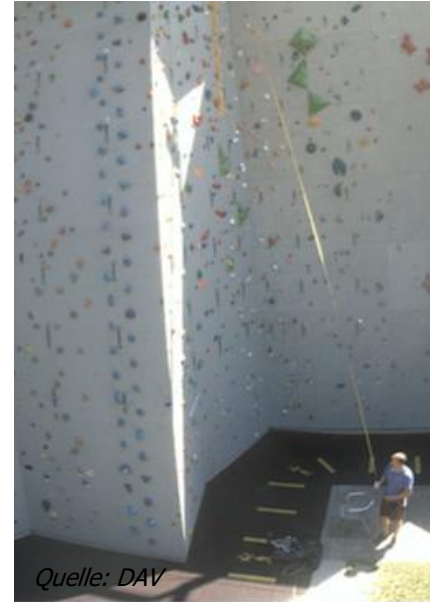
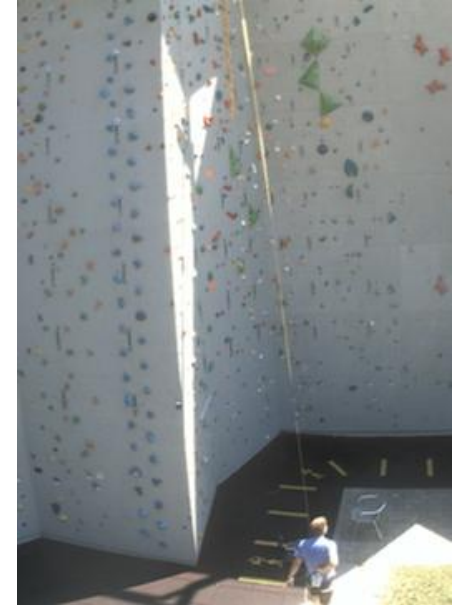
- Auto belay at the outdoor area is attached on a rail system.
- After climbing, the person takes a break and attaches the carabiner to his backpack.
- After the break, the person comes back to the climbing wall, chalking hands and looking at the climbing wall.
- The person starts climbing without being clipped in.
- The person falls and got seriously injured.

seriously
injured

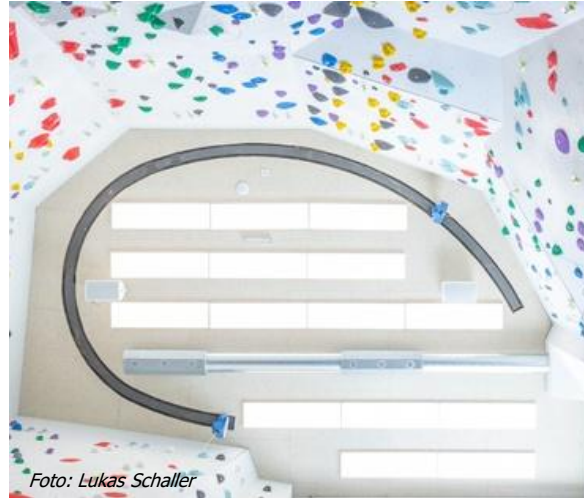
Auto belays on a rail systems allow climbing at the whole climbing wall
→ Fatal accident (64 aged)

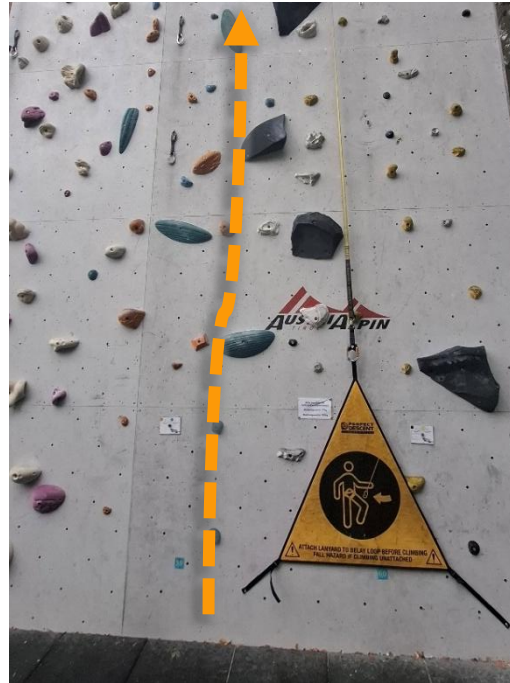
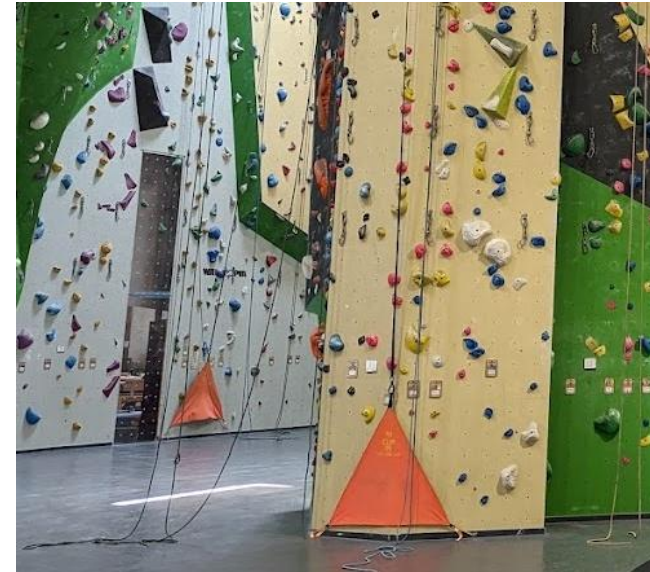
→ Entering at the edge or between belay gates

Climber started to climb the route next to the auto belay failing to clip in. The grade was close to her personal limit and she fell at a height of 4,5 m. It was supposed to be the last route, she had already packed the climbing belt into her backpack.

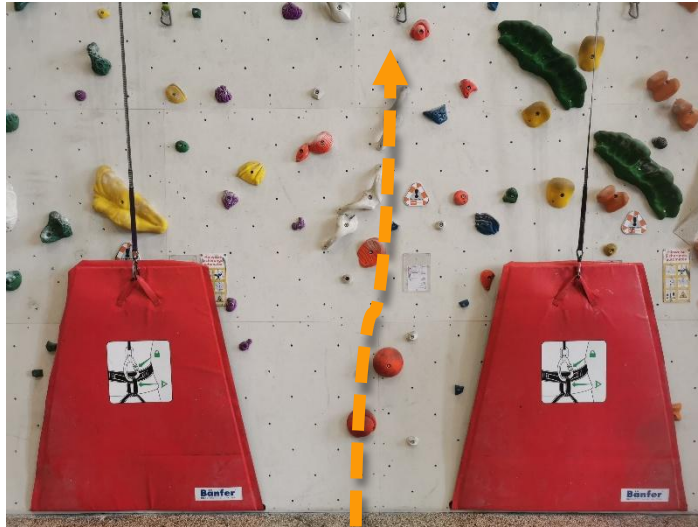
Climber climbed one time with auto belay, then talked with another climber about a climbing route. For the 2nd climb climber entered the route between the belay gates failing to clip in.

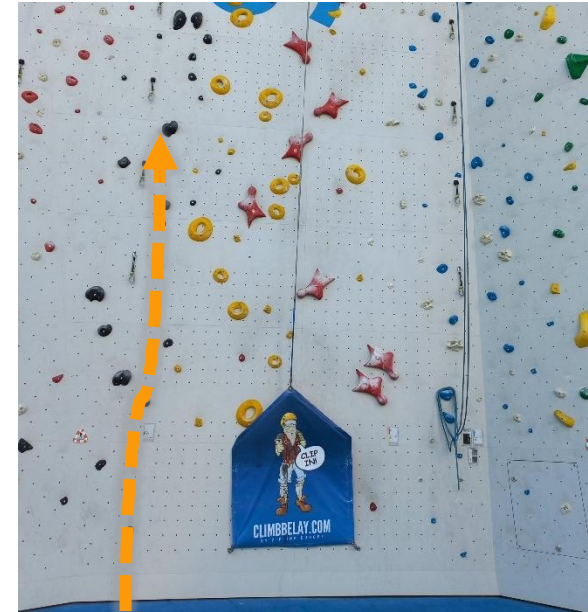
Climber started after a short break to climb the route next to the auto belay failing to clip in. At the time of the accident there was a top rope installed at the line.

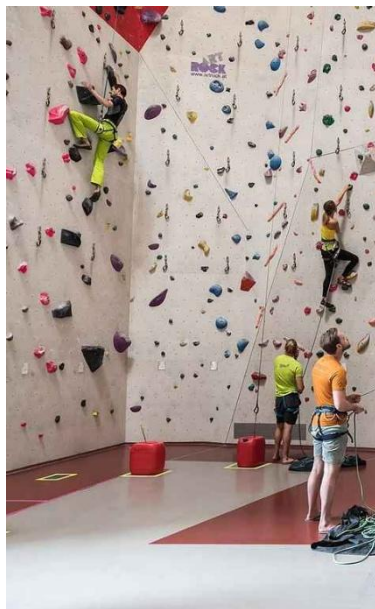
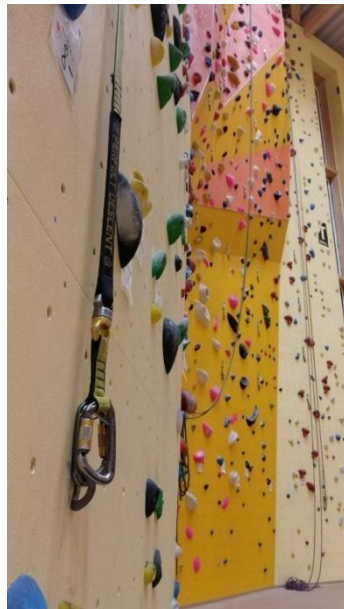
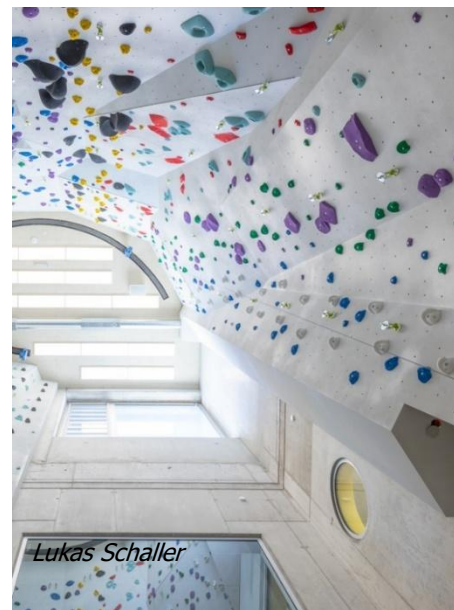
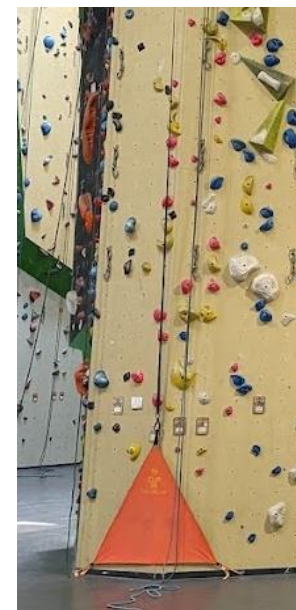
Examples: Carabiner hanging sideways or backwards without gate, auto belay on rail, auto belay and top rope
