Climbing Gym Meeting2025

Critical incidents, accidents, risks, and recommendations from the DAV for auto belay devices

Halls & Walls 22.11.2025, Lorenz Berker, Dr. Tanja Ganz – sifo@alpenverein.de

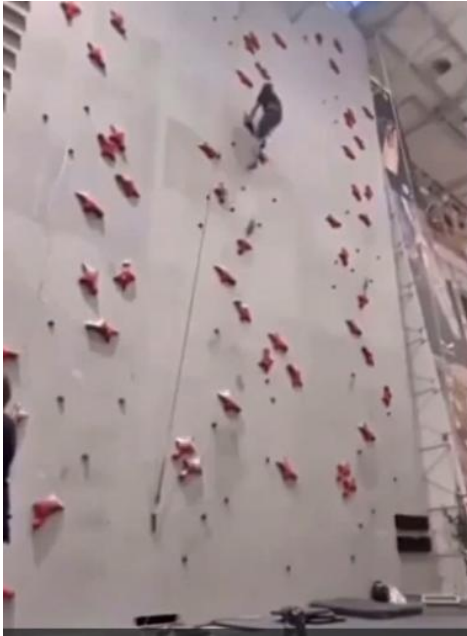
Accidents at Speed-Routes

Auto belays on a rail systems allow climbing at the whole climbing wall
→ Fatal accident (64 aged)

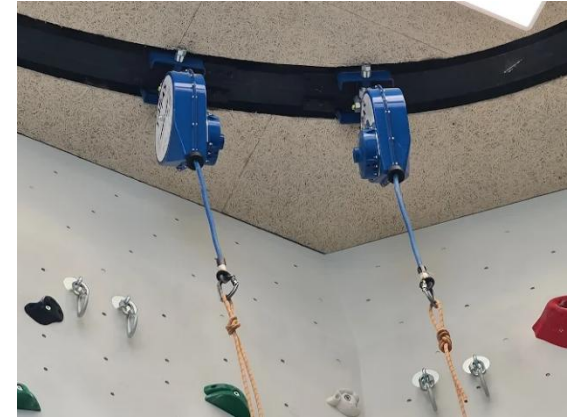
→ Entering at the edge or between belay gates

Climber started to climb the route next to the auto belay failing to clip in. The grade was close to her personal limit and she fell at a height of 4,5 m. It was supposed to be the last route, she had already packed the climbing belt into her backpack.
